### 3.1.10 Site CPP-25

### **3.1.11 Site CPP-58**

### 3.1.14 Site CPP-96

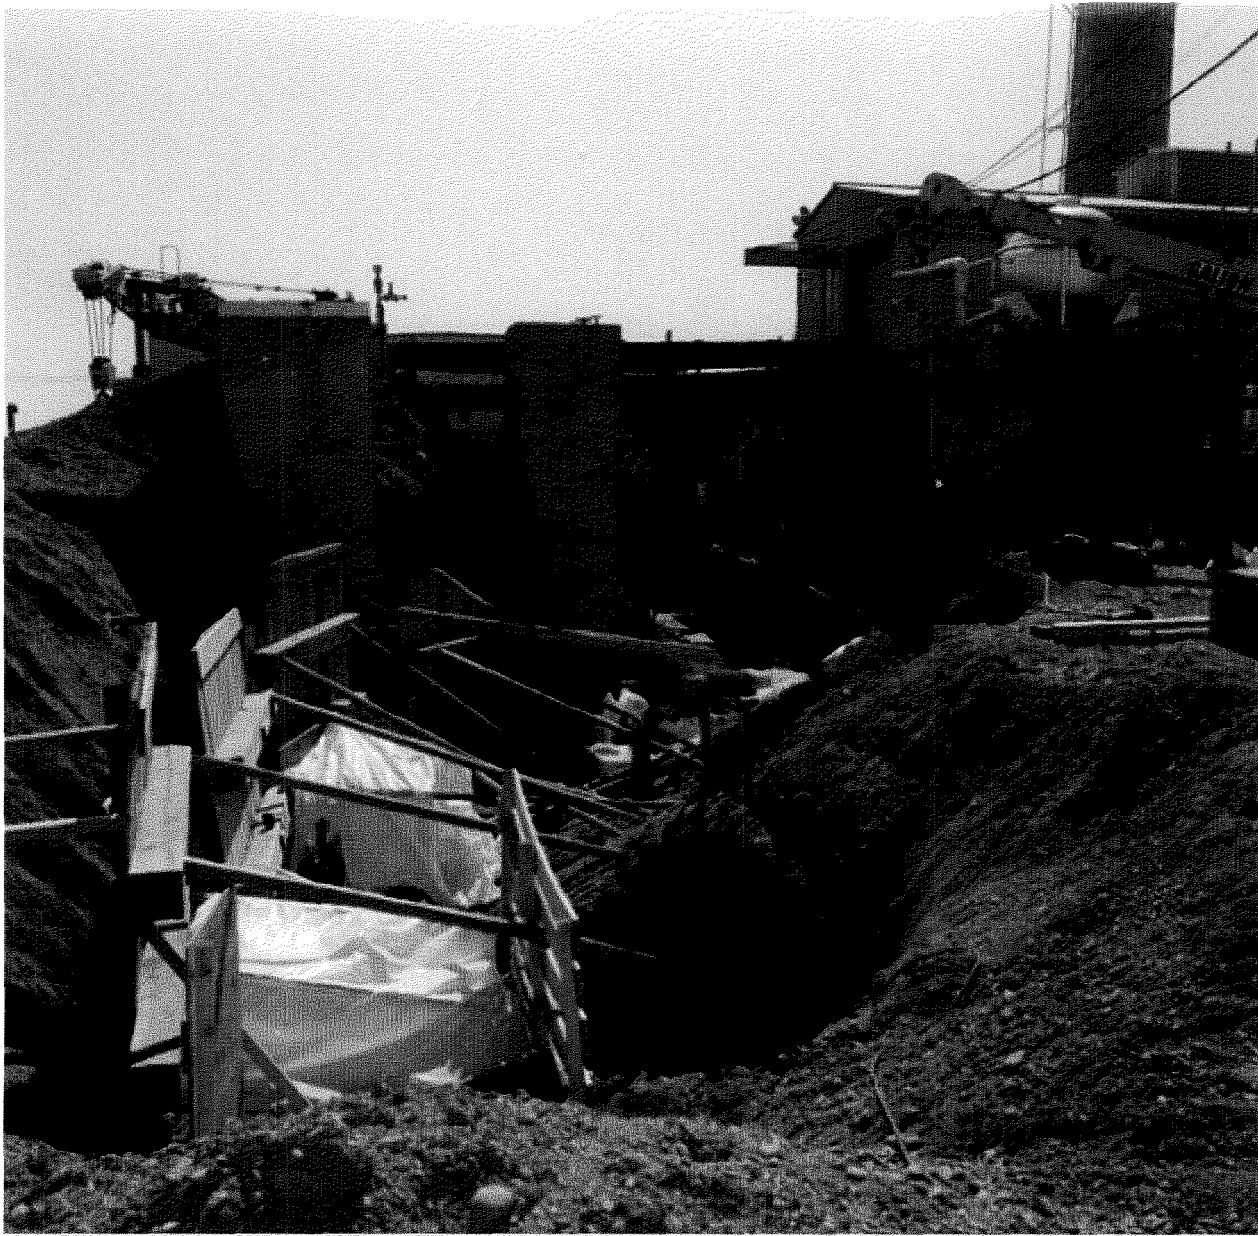
Figure 3-39. Eastern view of 1982 excavation north of building CPP-604 showing extent of excavation through the CPP-20 and CPP-25 release sites.

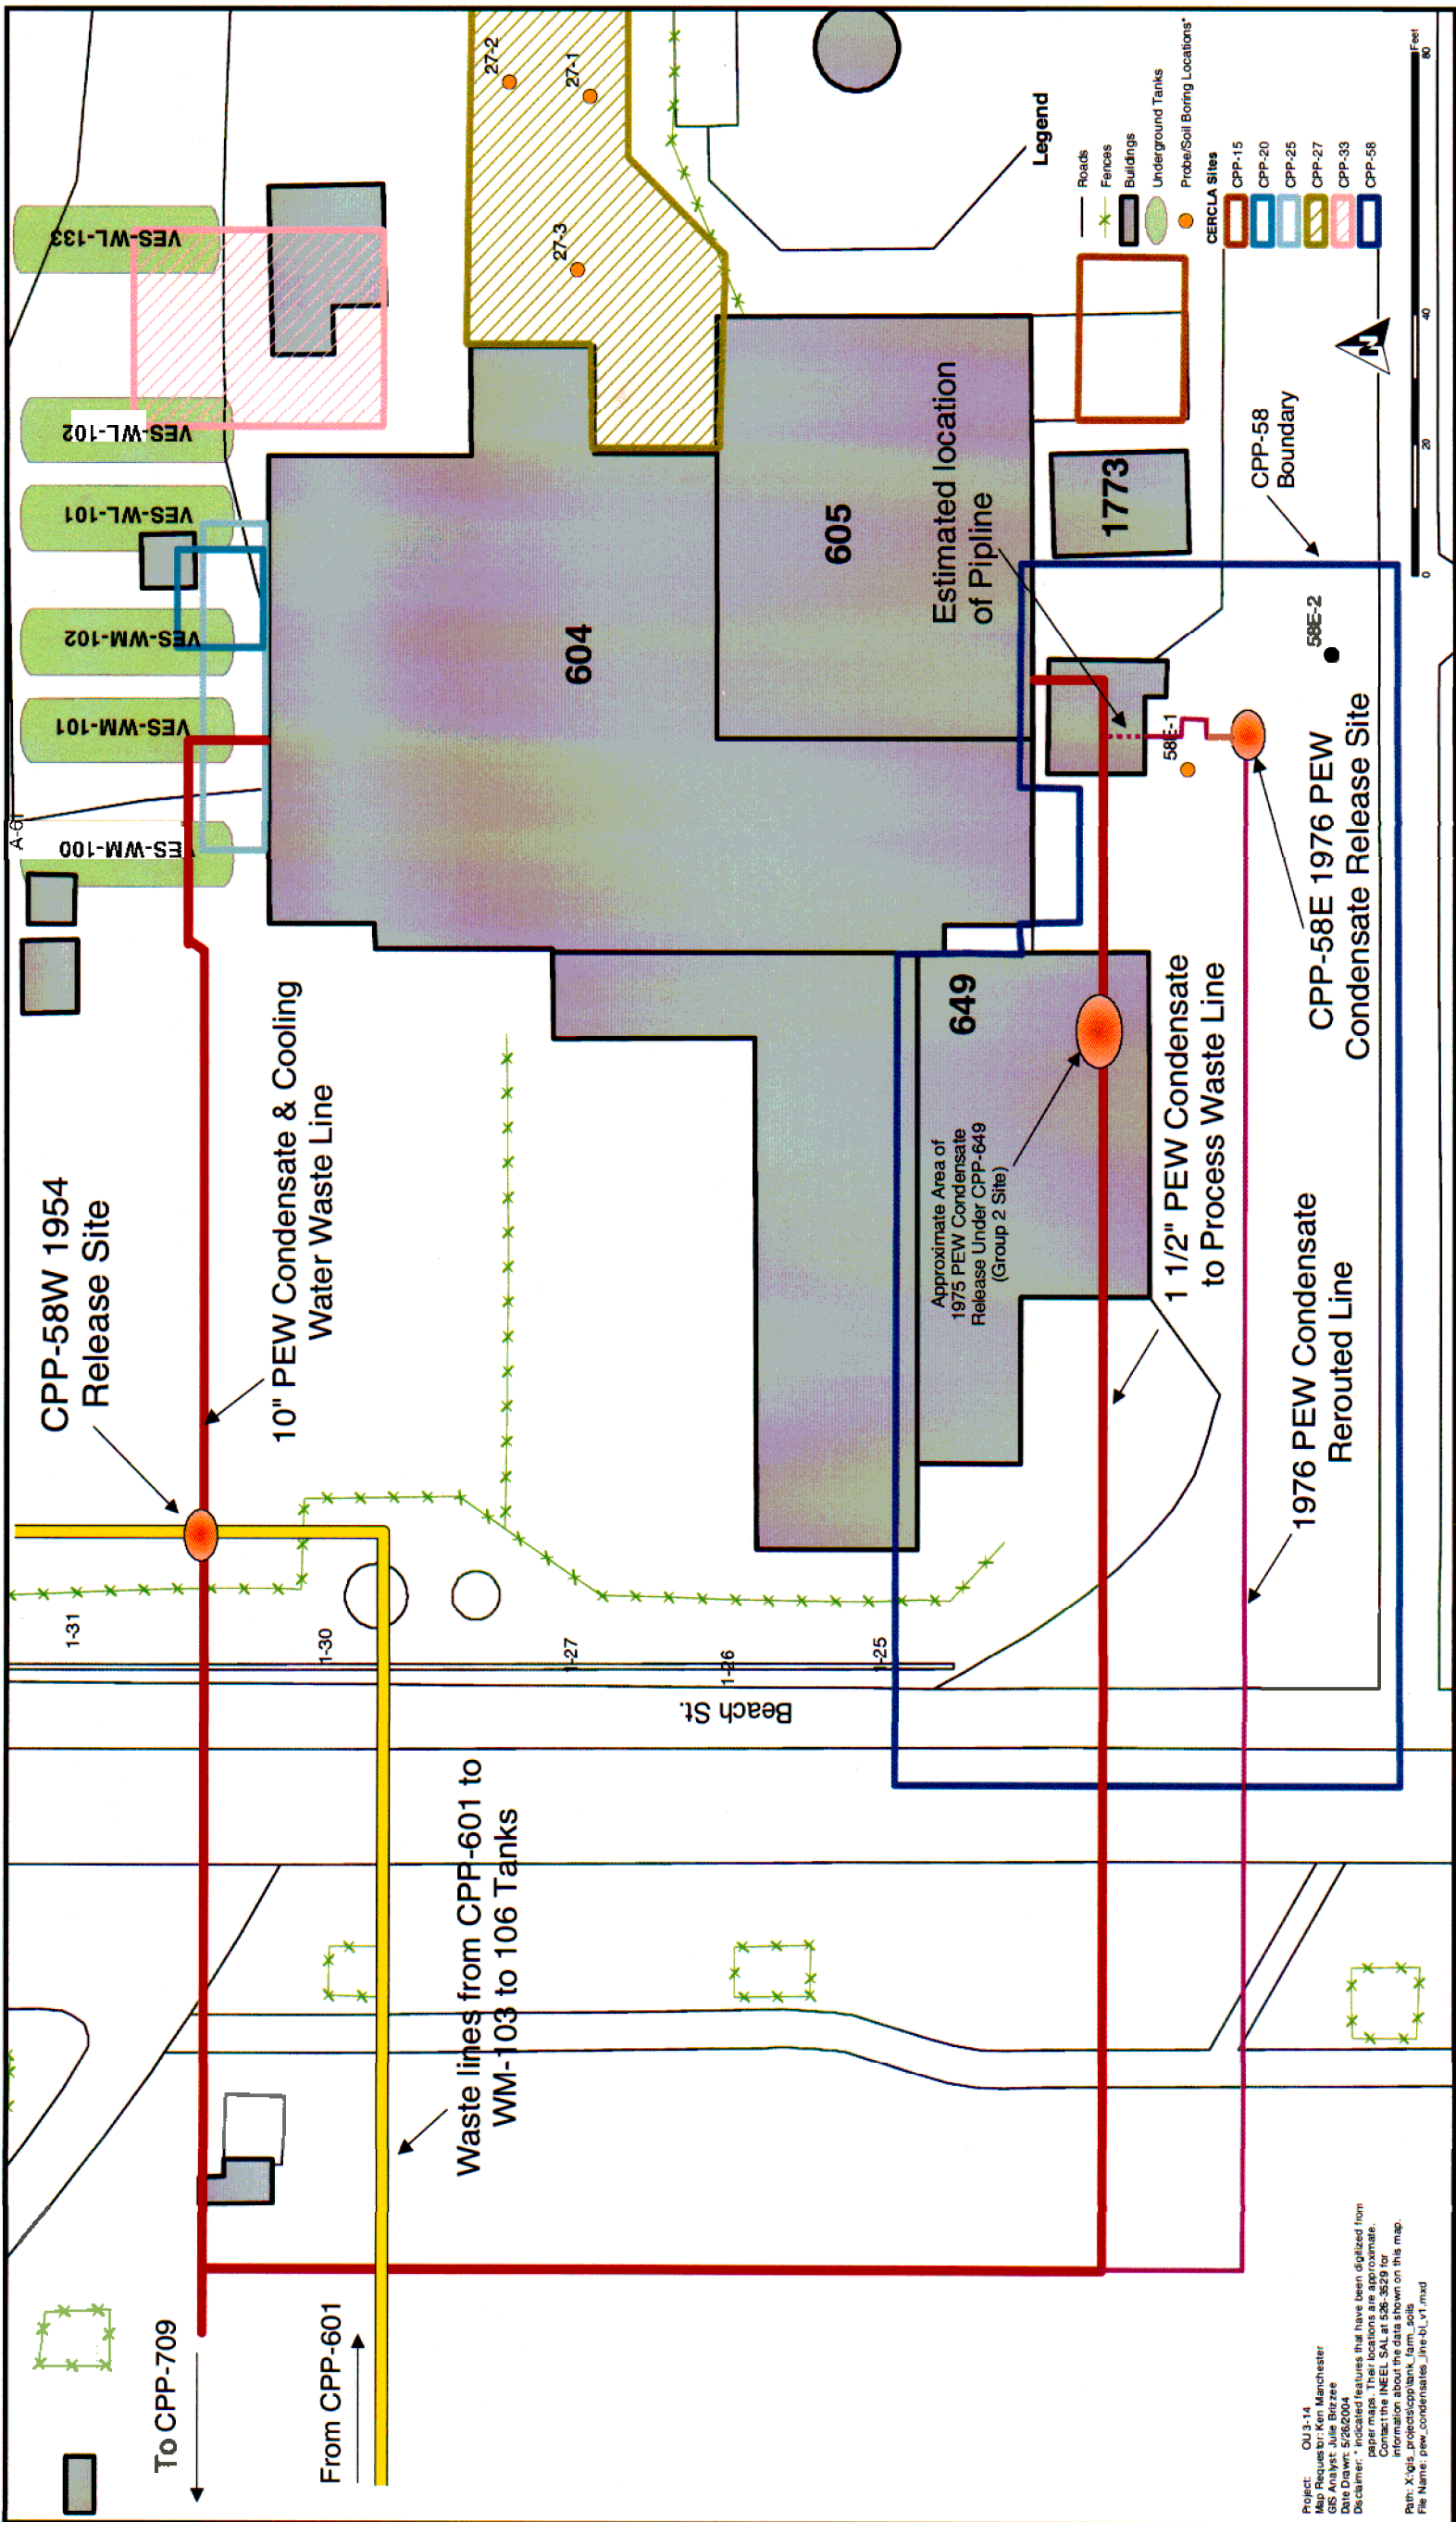
Figure 3-40. Map showing location of release site CPP-58, piping, and leak locations.

As part of the 1992 Track 2 investigation for OU 3-11 (WINCO 1993d), two boreholes were made at the CPP-58E site (see Figure 3-40). The locations of the boreholes were selected so that underground utilities would not be damaged. One borehole was drilled to 12 ft bgs and was located approximately 30 ft southwest of the release. The other borehole was drilled to 46 ft bgs and was located within 12 ft of the release site. Plans called for samples to be collected from intervals exhibiting the highest gamma/beta radiation fields as measured with field instruments. However, no radiation above background was detected in either borehole; therefore, samples that were representative of the entire drilled intervals were collected. Thirteen samples were collected from the two boreholes and analyzed for VOCs, selected metals (mercury and cadmium), fluoride, nitrate, nitrite, pH, and radionuclides.

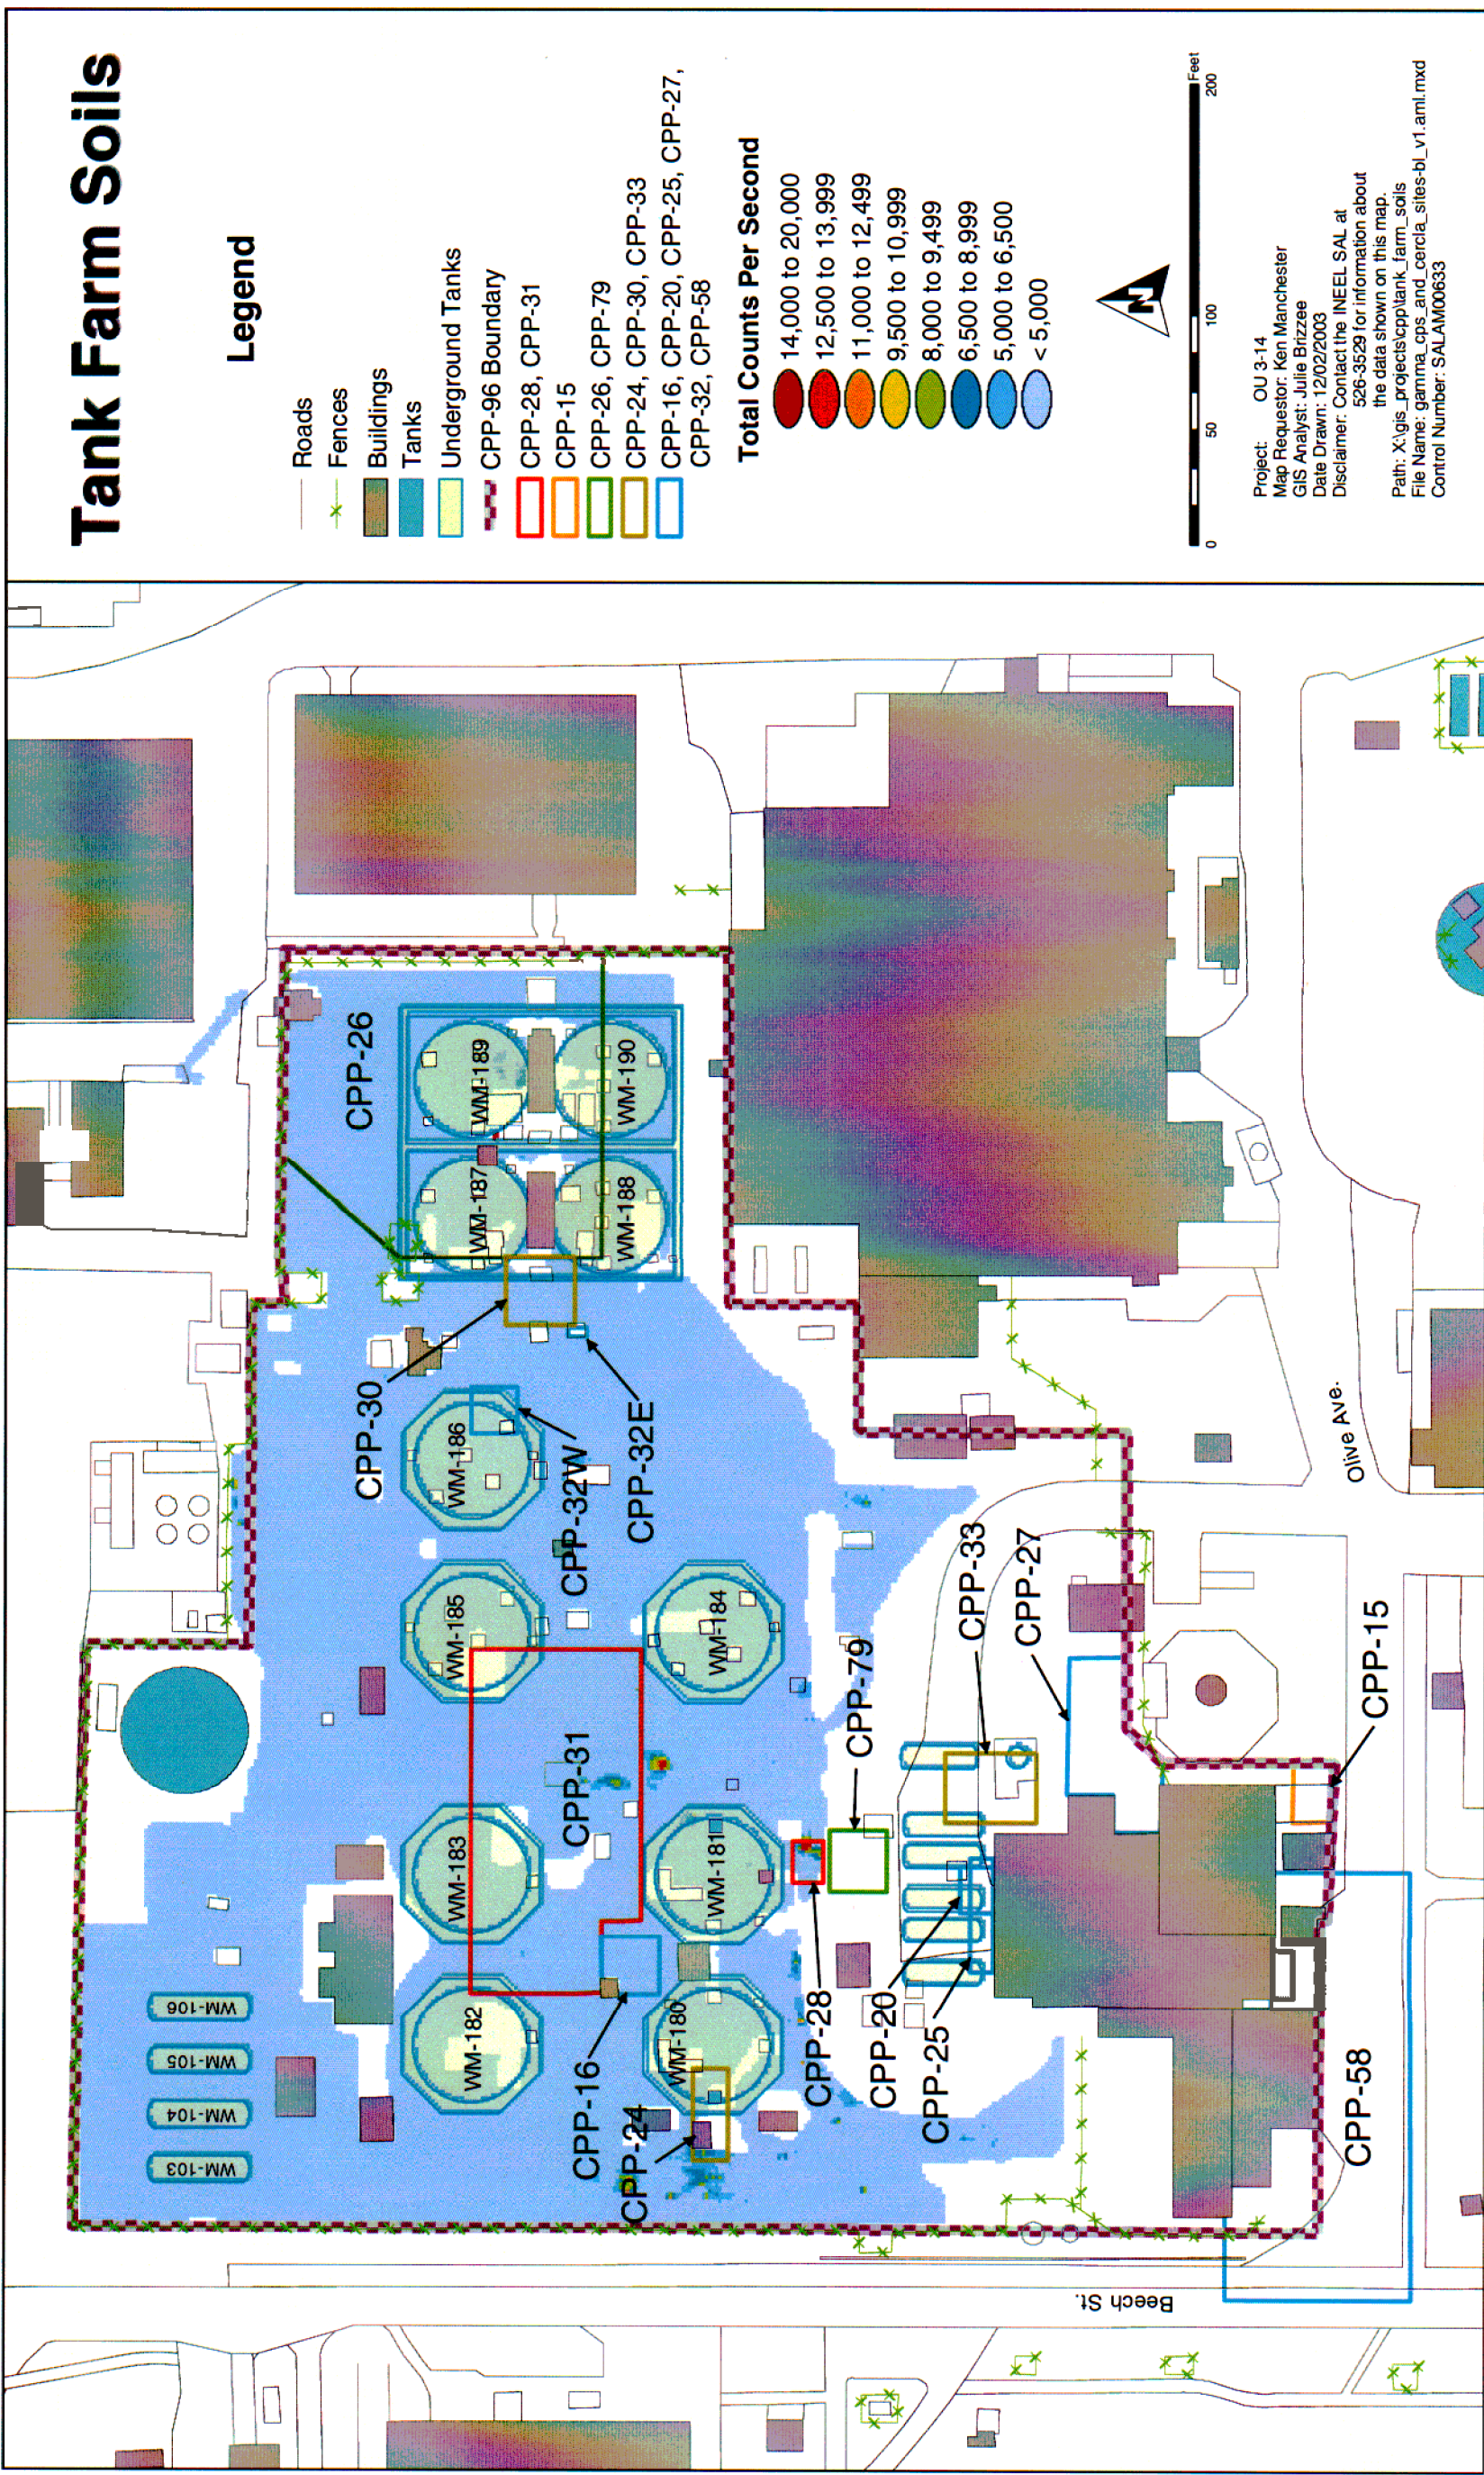
Figure 3-41. Tank farm map showing surface gamma survey results.

indicated that most of the readings were at or near what are assumed to be background levels. Small areas were found to have elevated gamma counts, but no quantification of these locations could be performed. Taking the highest readings for those areas and converting them resulted in approximate radiation levels between 2 and 3 mR/hr, making general assumptions for the instrument efficiency and detector area.

Due to the limitations of surface gamma survey, no follow-up survey will be performed under this RI/FS Work Plan. The gamma survey that was performed is not of much value for the following reasons: (1) The instrument cannot distinguish a surface area of contamination from a single hot particle on the surface or distinguish the depth below ground surface of detected contamination (surface surveys are used to detect the contamination at the surface). (2) If these surface areas were above the allowable radiation limit for worker protection, tank farm operations, which includes surveying the tank farm surface, would have followed procedures to have the area cleaned up to meet worker radiation limits. (3) The instrument used was not calibrated and therefore the cps have no direct meaning to mR/hr. Further reasons why a follow-up survey should not be performed include (1) the hot surface area identified within the boundary of CPP-28 is an area that will be sampled in the OU 3-14 investigation and (2) one of the identified surface hot spots is very close to probe hole A53-12, which is non-detect.

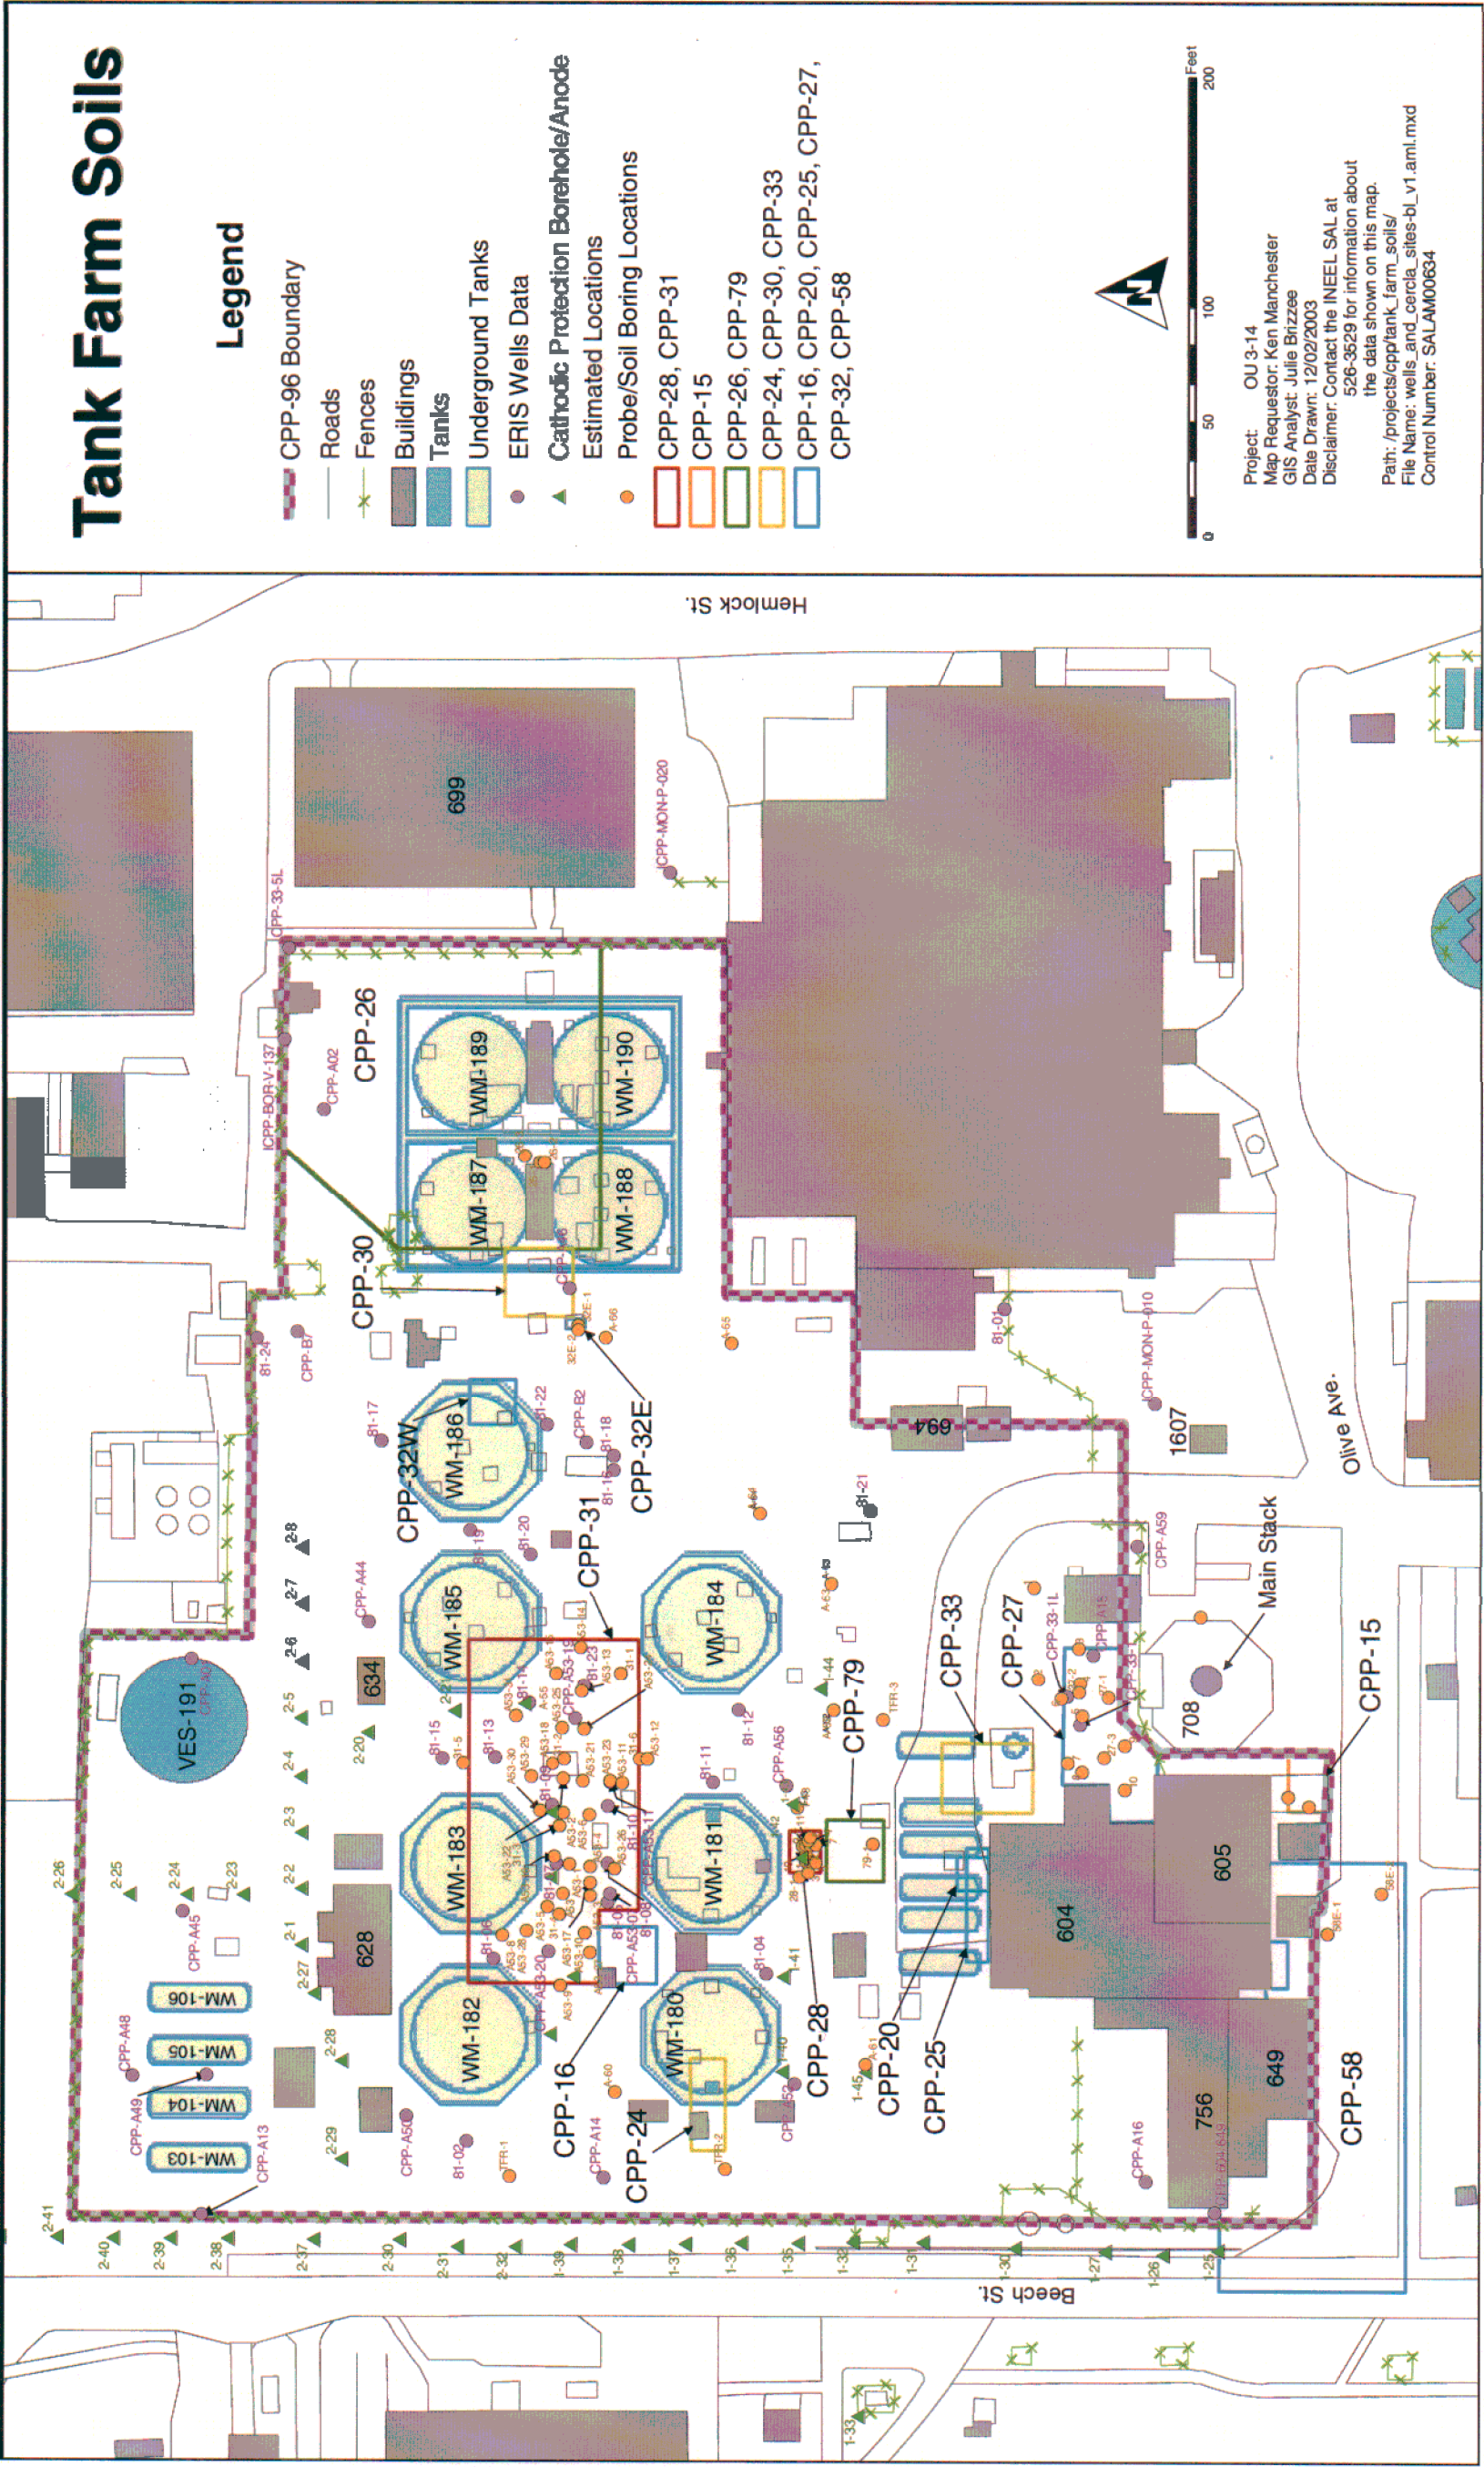
Figure 3-42 shows the CPP-96 site boundary and well, soil-probe, characterization-borehole, and cathodic-protection borehole locations from previous investigations and tank farm upgrades. The number of penetrations into the tank farm area is large and reasonably distributed across the CPP-96 boundary. If any additional major waste releases occurred at the tank farm, like CPP-31, penetrations would likely have encountered the contamination. The probes and boreholes, either directly or indirectly, helped to screen the tank farm soil for undiscovered release sites.

Figure 3-42. Tank farm map showing wells, cathodic-protection boreholes/anode estimated locations, and probe/soil-boring locations.
